Structural Health Monitoring of a Bonded Composite Patch Repair on a Fatigue-Cracked F-111C Wing

DSTO-RR-0335

In 1994 a large (48 mm) fatigue crack was discovered in the wing skin A15-5 of an Australian Defence Force F-111C aircraft, following the investigation of a fuel leak. A decision was made to repair the crack using an adhesively bonded boron/epoxy fibre composite patch. This decision was based on the availability of crack-patching technology, pioneered and developed by DSTO.

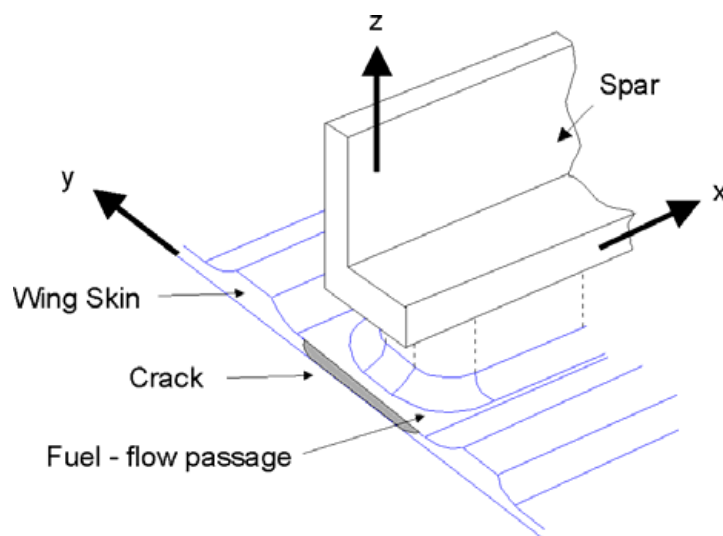
Figure 2: Local geometry of wing skin in the vicinity of the fuel flow passage

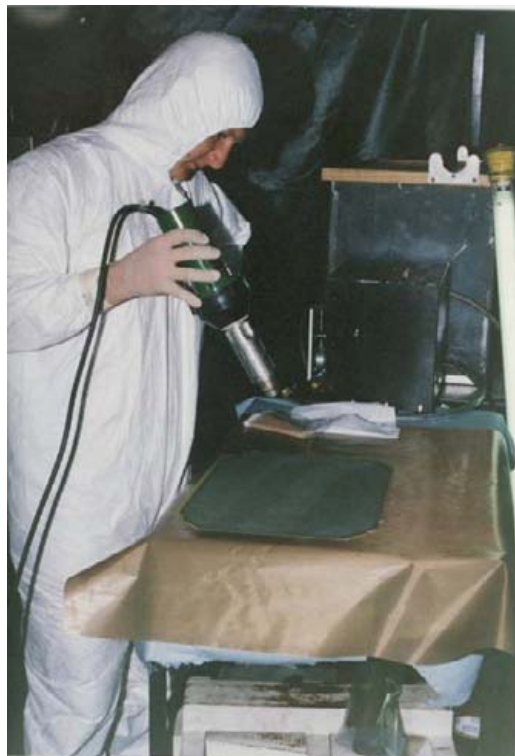
Figure 5: RAAF technician applying the FM 73 film adhesive to the bonding surface of the patch after a light abrasive blast with alumina grit

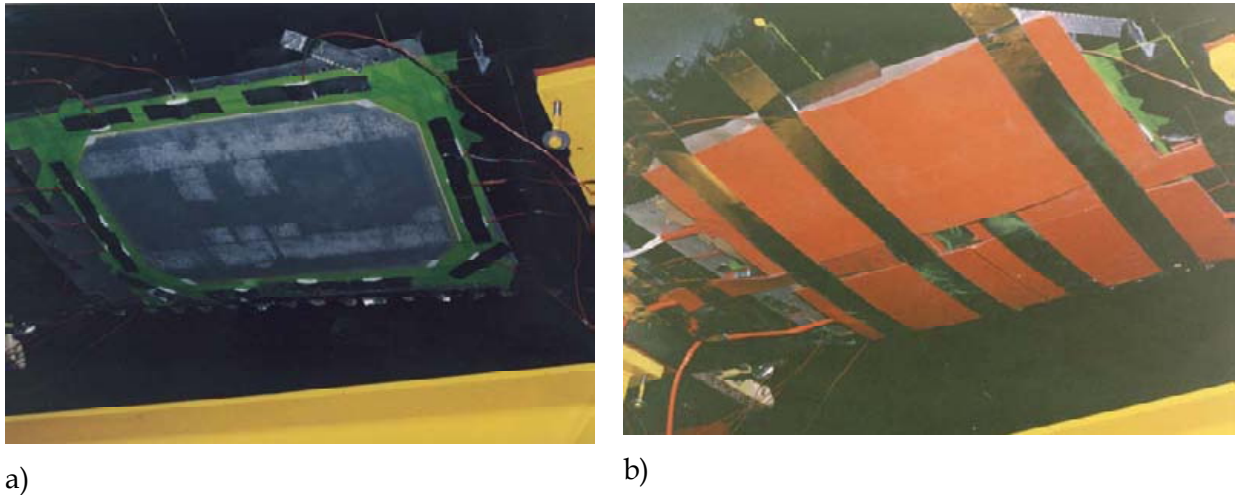
Figure 6: Showing a) patch with film adhesive on the bonding surface taped to the lower surface of the wing over the crack, ready for bonding, b) patch under silicone rubber heat blanket; the thermocouple wires and electrical connection to the blanket can also be seen

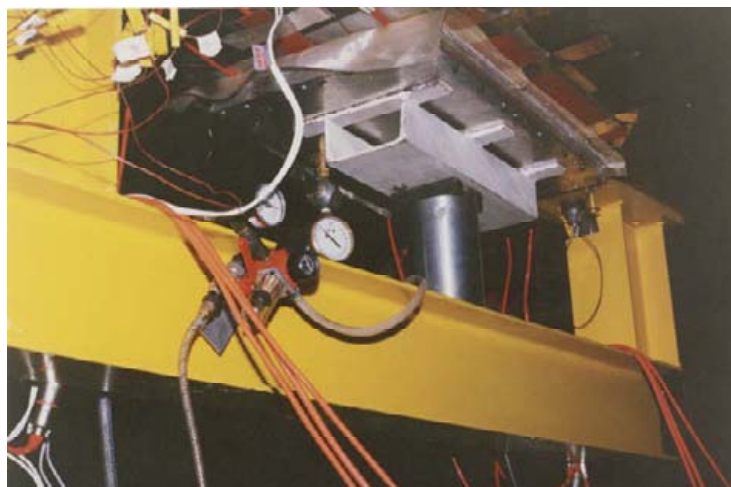
Figure 7 : Ground support equipment used by RAAF for applying pressure to the patch through a caul plate

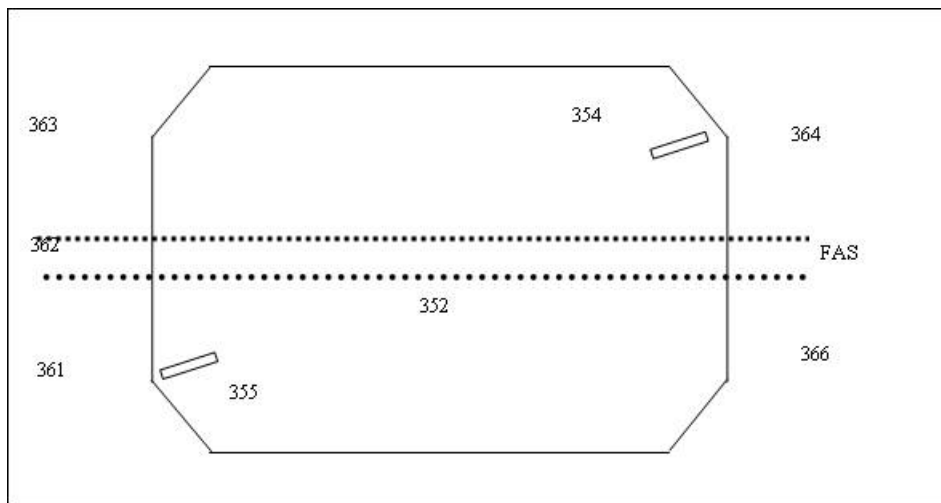
It is, however, important to note that, as indicated in Figure 8, NDI had already detected suspected disbonds and several of the strain gauges were bonded over these regions. Thus these gauges would be expected to provide low and possibly anomalous readings from the time of application.

Figure 20 Location of strain gauges used on the patch and parent structure at Block 6

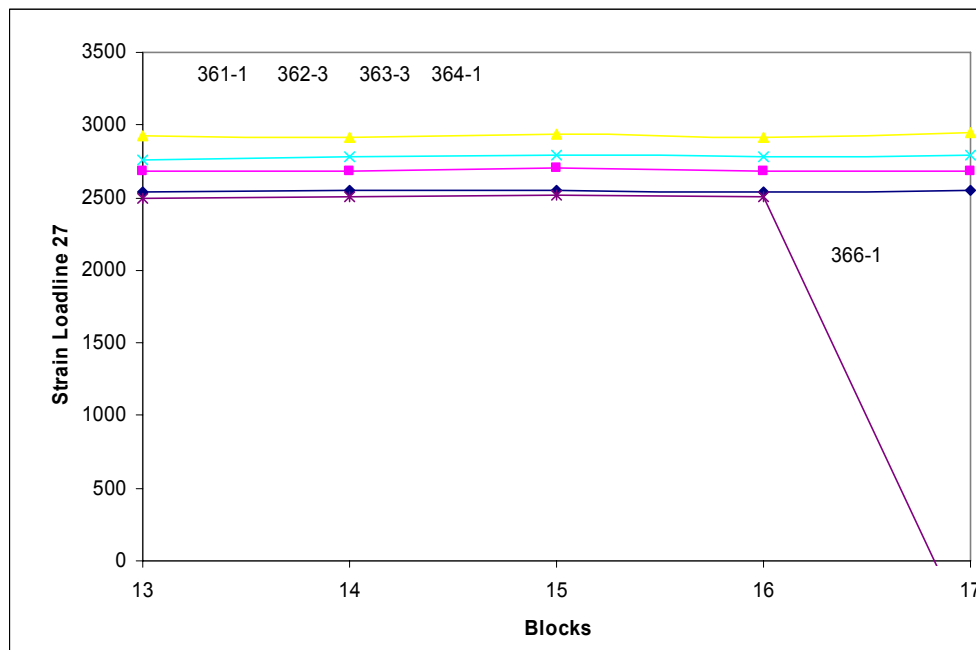
Other than gauge 366, which appears to have failed after 16 blocks of cyclic loading, the readings on the wing skin show excellent consistency and provide a good indication of the repeatability of the loading and reliability of most of the gauges.

It is also notable from Figure 23 that at least for load-line 27, and probably for most of the other loading conditions, that the strain in the wing-skin around the periphery of the patch is quite uniform for load-line 27.

Figure 23 Strain at load-line 27 versus blocks for gauges bonded on the wing skin

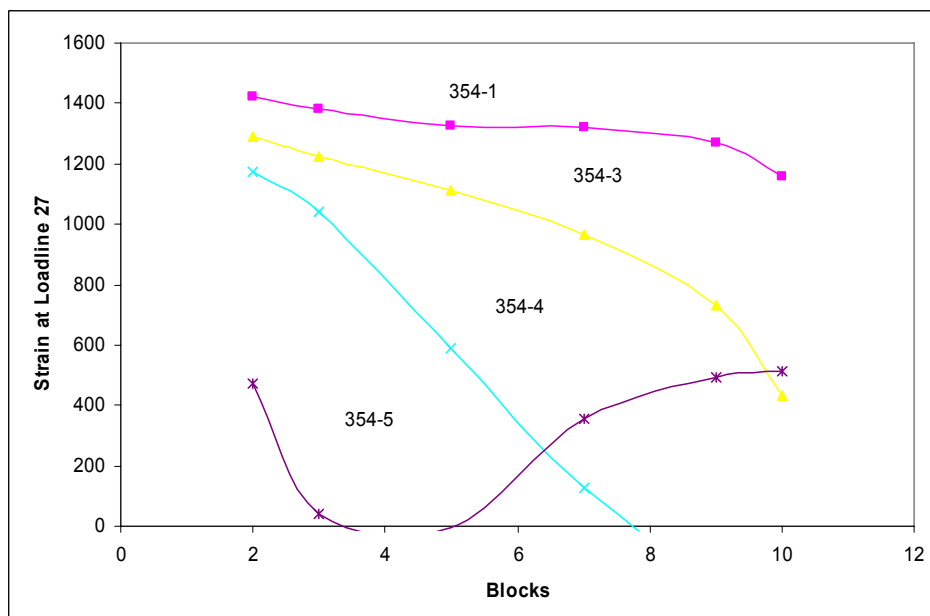
Figure 24: Strain versus block number for strip-gauge 354 for Blocks 2 to 12; the skin gauge location is 364 and patch gauge positions are as indicated in Figure 20

The results should be compared with the disbonds shown in Figure 8 top right (for the region located near the prospective location of wing-skin gauge 364) that corresponds with zero blocks of fatigue loading in the test.

If gauge 354-5 is ignored for the moment, this Figure shows that the gauges detect the gradual growth of disbonds in this region. As expected, the strain magnitude registered by the gauges increases moving in from the edge of the patch. Disbond growth is indicated by gradual decrease in strain in most of the gauges with blocks of fatigue loading; Figure 13 shows the disbonds in this region detected by NDI at Block 10.

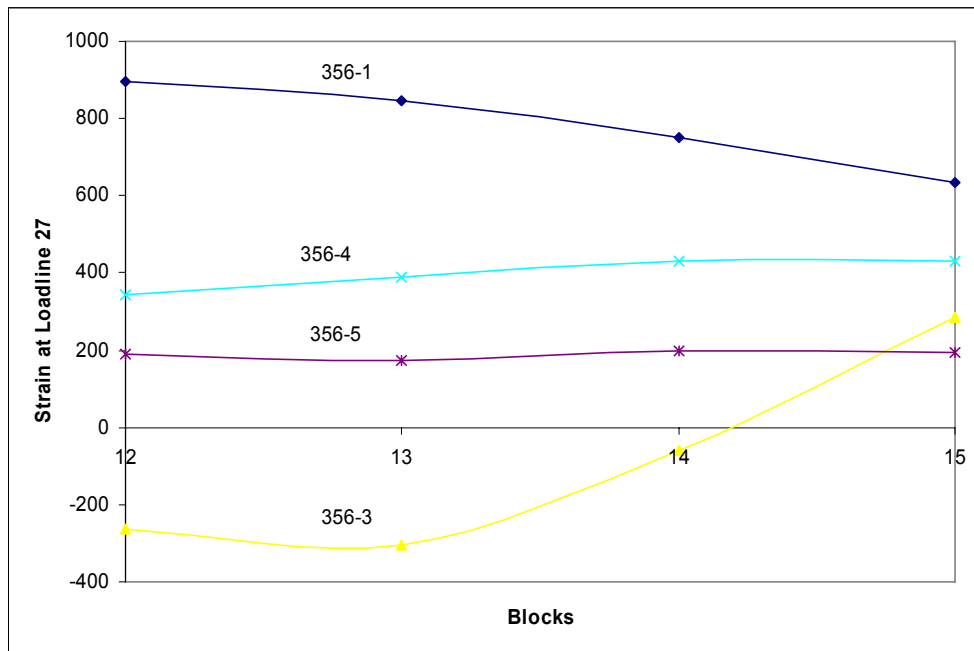
- Strip-gauge 356, Figure 26,
 - The low strain readings from gauges 3 to 4 indicate of the presence of pre-existing disbonds, in agreement with NDI, see Figure 13. Only 356-1, which is

Figure 26: Strain versus block number for strip-gauge 356 for Blocks 12 to 15; the relevant wing-skin gauge location is 364. NDI indications of pre-existing disbonds are shown in Figure 13

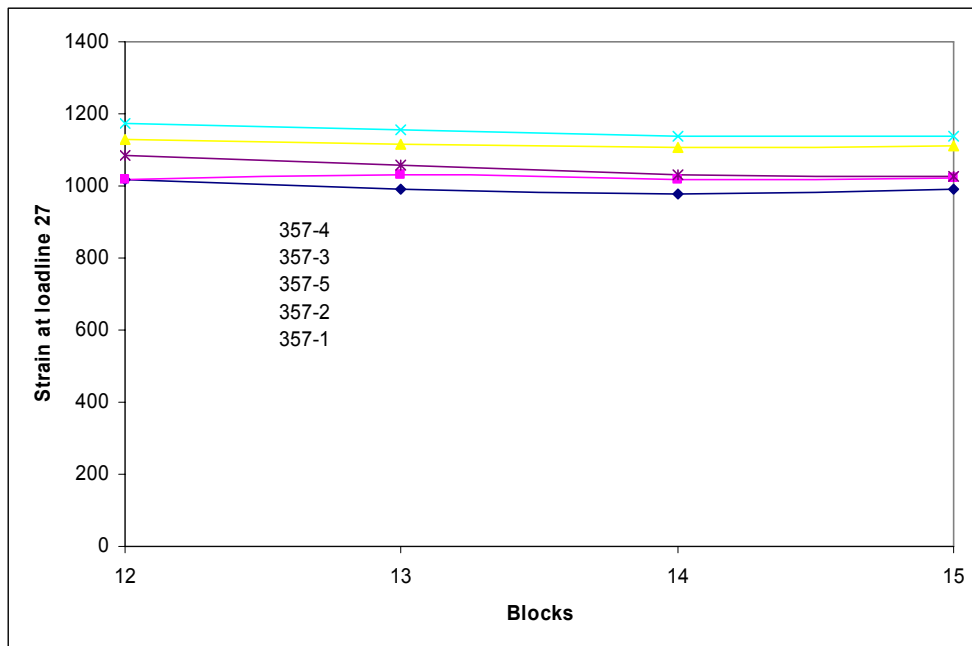
- Strip-gauge 357, Figure 27
 - This strip gauge is further into the patch than 356, so as expected indicates no disbonding, in agreement with the lack of damage found by NDI in this region, see Figure 13.

Figure 27: Strain versus block number for strip-gauge 357 for Blocks 12 to 15; the relevant skin gauge location is gauge 364

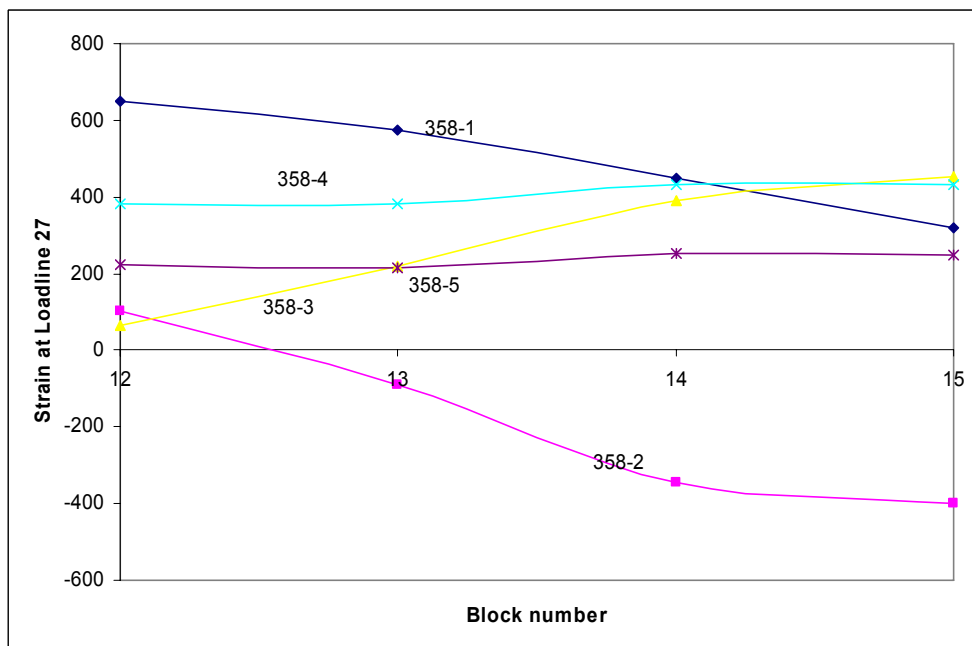
- Strip-gauge 358, Figure 28
 - This strip gauge provides somewhat confusing information. The gauges are clearly located in a disbonded region and there is indication from some of the gauges that the damage is slowly growing. Gauges 358-3 and 358-4 appear to be giving anomalous strain readings only 358-1 indicates possible further disbond growth. However, gauge 5 would be expected to provide the lowest strain readings, not gauge 2. NDI indications from this region are provided in Figure 15.

Figure 28: Strain versus block number for strip-gauge 358 for Blocks 12 to 15; the relevant skin gauge location is gauge 361

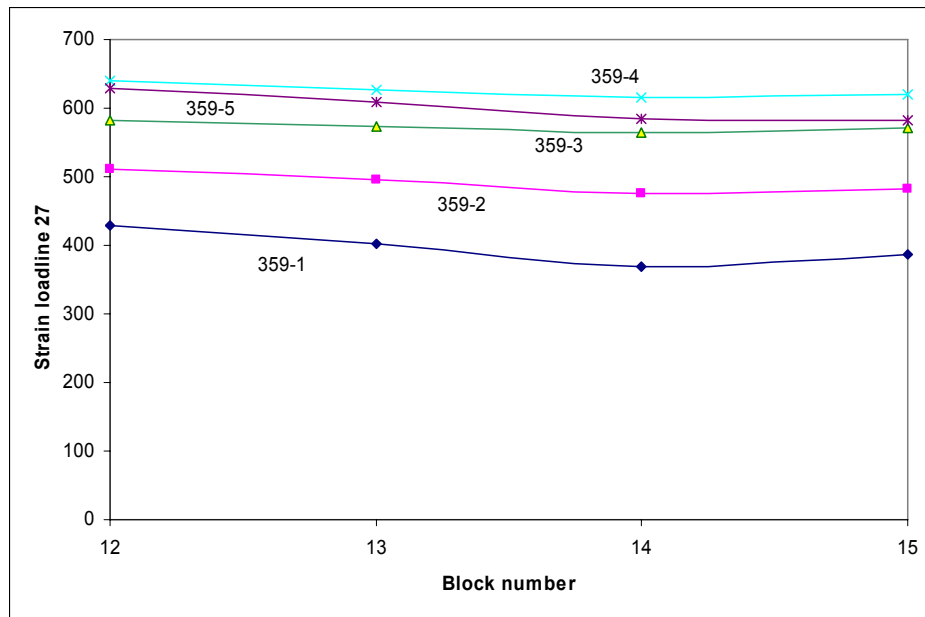
- Strip-gauge 359, Figure 29
 - This strip gauge, which backs onto 358, also presents confused information, but indicates no damage growth. Gauge 359-5 should be closest to 358-1 but the other readings, especially from gauges 1 and 2 should then be similar or higher, not lower. No damage growth is indicated.

Figure 29: Strain versus blocks for strip-gauge 359 for Blocks 12 to 15; the relevant skin gauge location is 361
